GEORGETOWN RESIDENTIAL ARCHITECTURE - NORTHEAST

Northwest Washington, District of Columbia

Historic American Buildings Survey Selections

Number 5

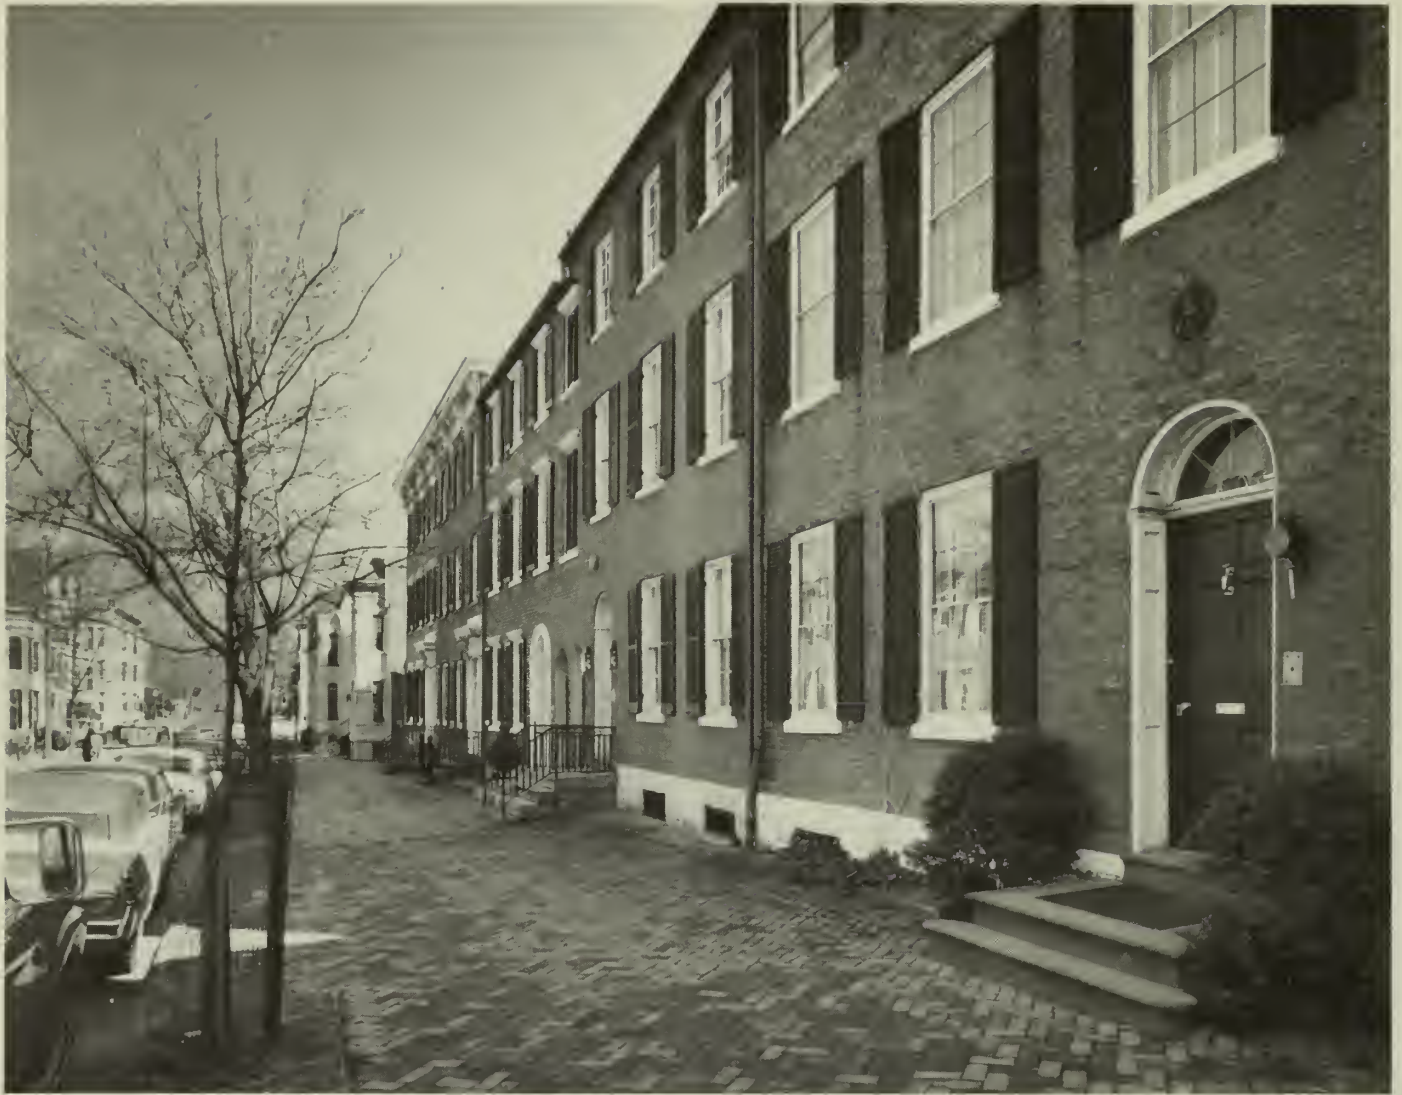
Smith-Morton Row Houses

This early nineteenth century streetscape is one of facade continuity and understated individuality.

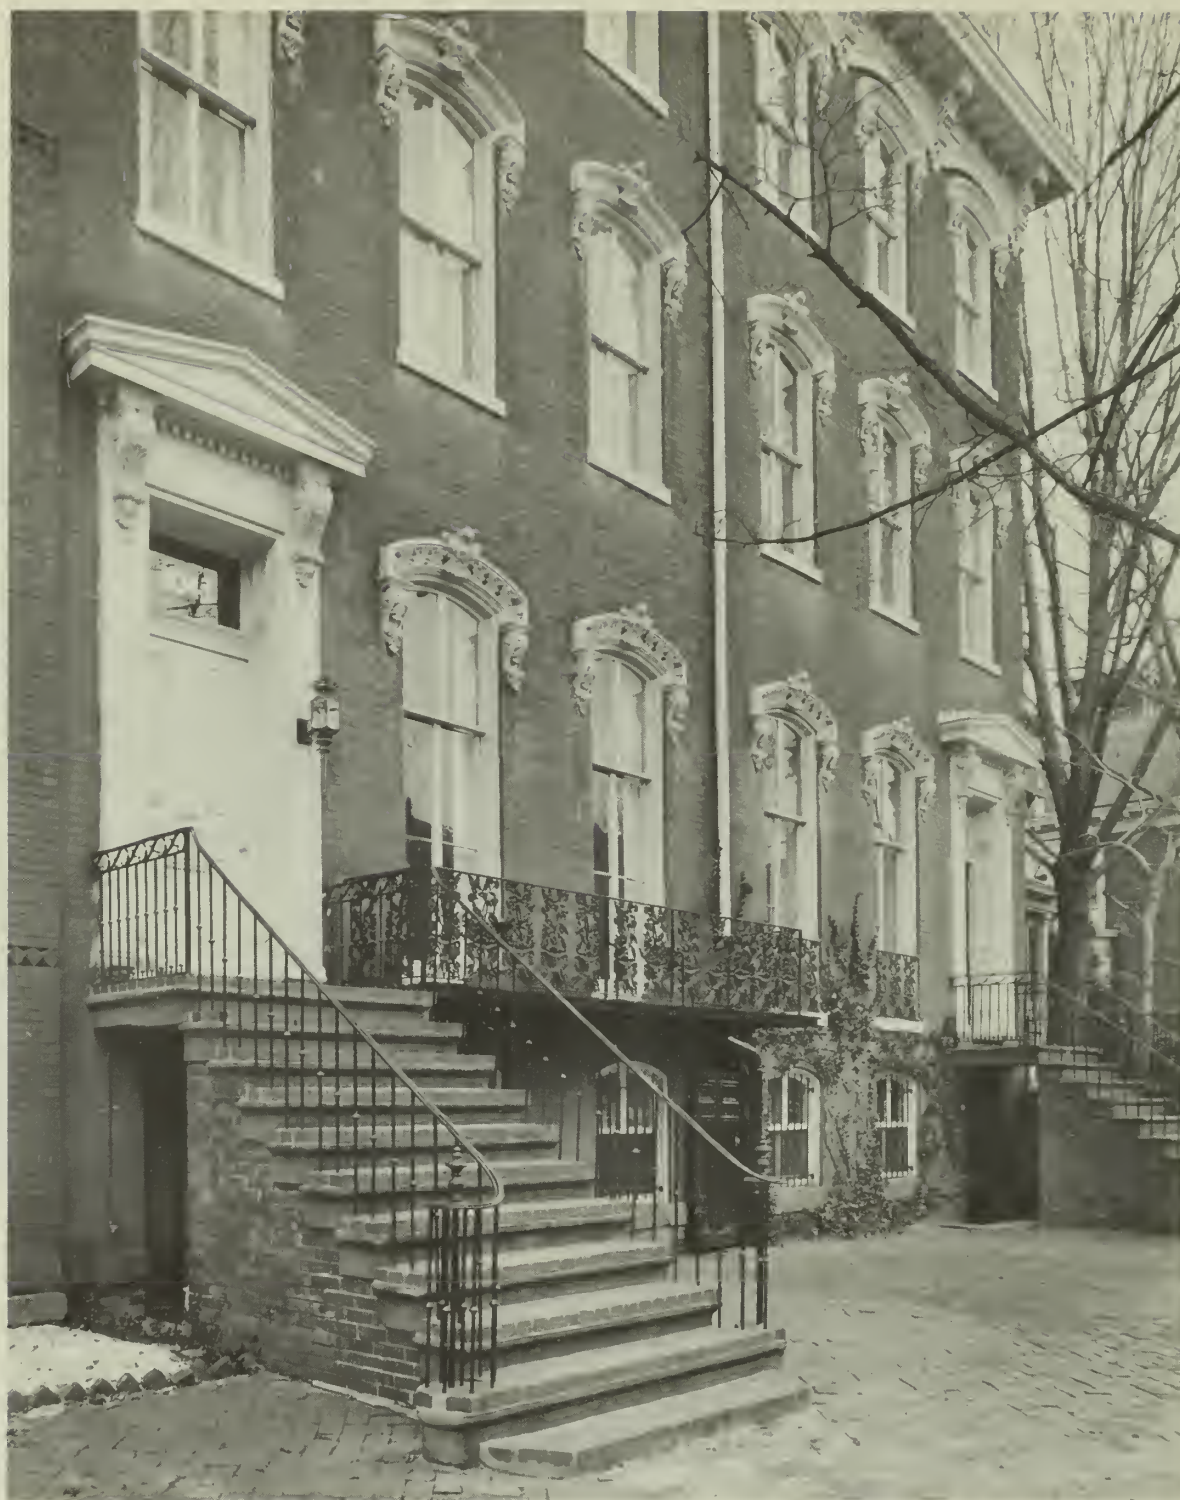
Wheatley Town Houses

This mid nineteenth century row combines earlier geometric simplicity with Victorian detail enrichments.

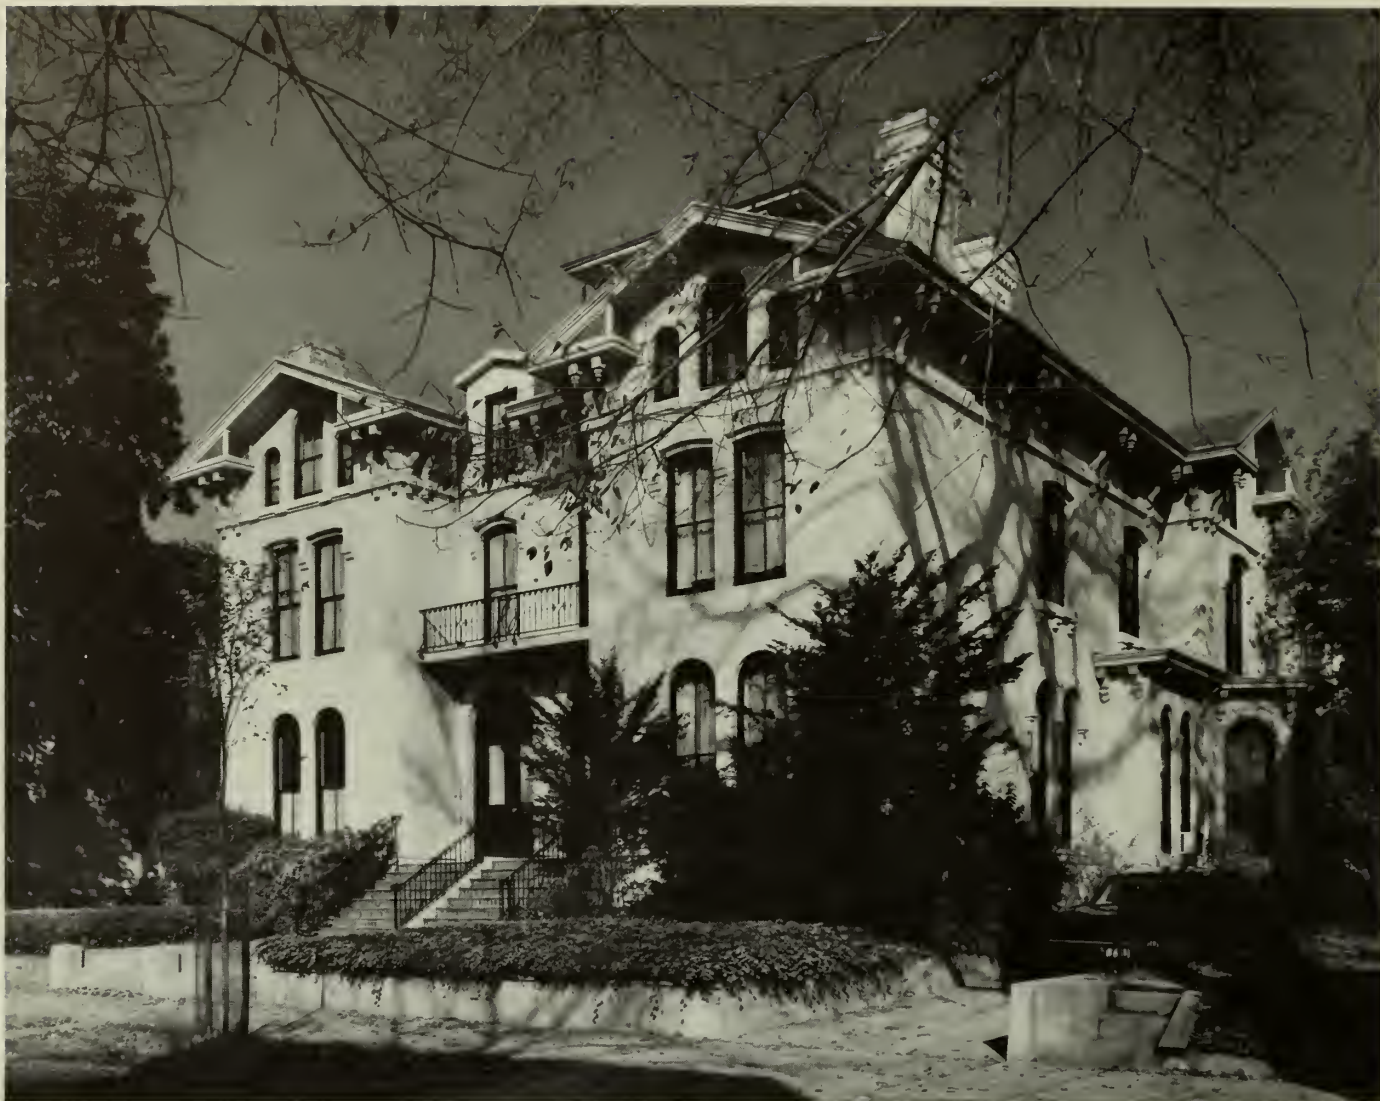
Cooke's Row, Villa No. 3

These late nineteenth century picturesque villas break with the usual row house pattern to recognize the Victorian desire for variety, individuality, and a more natural setting.

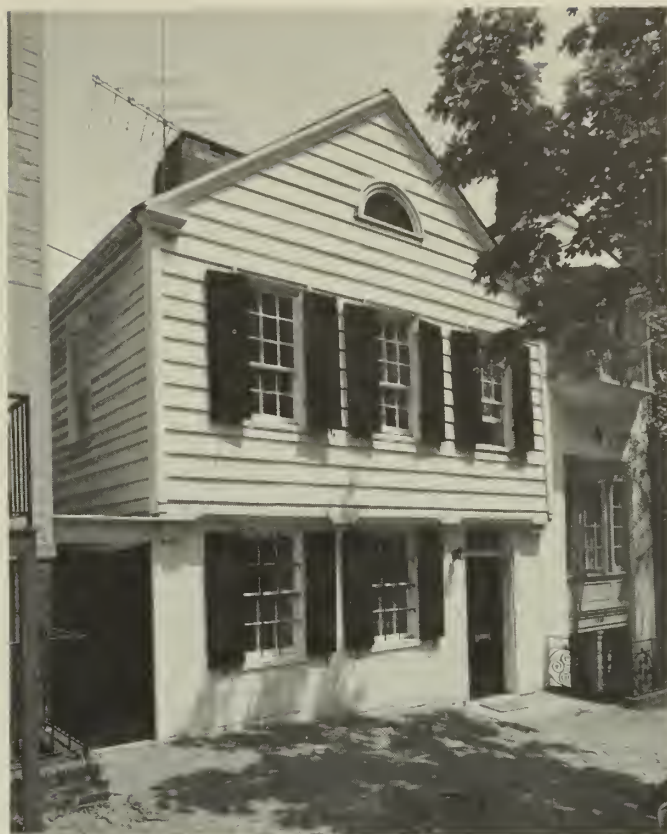
Edgar Patterson House
facade

2. Condition of fabric: The house is in good condition on both interior and exterior. There has been some remodelling to make the house servicable for 20th century living. There are also two major alterations. First, it appears that the original entry to the house was at what is now the position of the southern most second floor window of the facade. This is surmised from evidence of repair of the flooring at that position and from the fact that before 1830, 30th Street was considerably higher at this point, but was excavated in connection with the building of the C. and O. canal after 1830. A second major alteration was the addition of a 3 story brick kitchen addition to the northeast of the main block adjoining the present dining room. This addition appears to be of early to mid-19th century date.

1. Overall dimensions: This two story brick and frame house faces west onto 30th Street between Olive and N Streets and its south wall is approximately 105' north of the centerline of Olive Street. The house has a 3 bay facade about 20' in length and is approximately 40' in total depth.
2. Foundations: At present the house is on grade at the facade while at the east elevation the rear yard is excavated so that a basement level opens directly out onto the rear yard. Foundation material is brick.

- b. Windows and shutters: Windows at the ground floor typically are 6/6 light double-hung wood sash. Those at the second floor are 9/6 light double-hung wood sash. These windows appear to be 20th century replacements of earlier units. Shutters are used at the facade for both first and second floor windows. These are single panel fixed louvered and painted black.

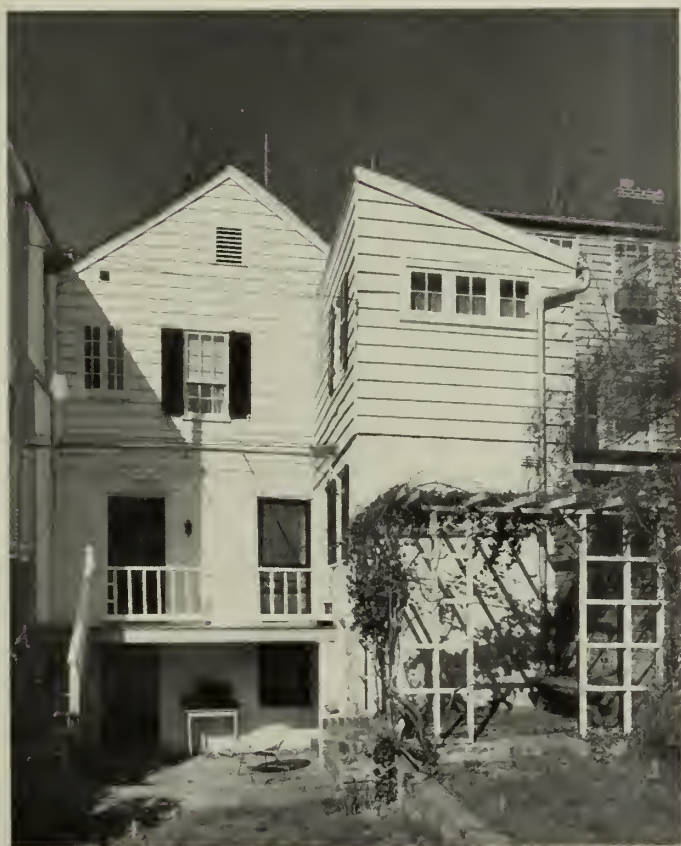
rear view

2. Enclosures: The rear yard is enclosed by 7' high brick wall at the east and a 10' high brick retaining wall at the north. The south side of the yard is closed by a 5' high wood fence.
3. Outbuildings: Foundation remains located 27' east of the east wall of the kitchen ell and at 8' from the north brick wall of the rear yard have not been identified with any particular past function.
4. Walks: The dwelling fronts onto a brick herringbone pattern sidewalk.
5. Landscaping: A brick patio the east of the kitchen ell is about 9' square. A medium sized maple tree shades the facade on 30th Street.

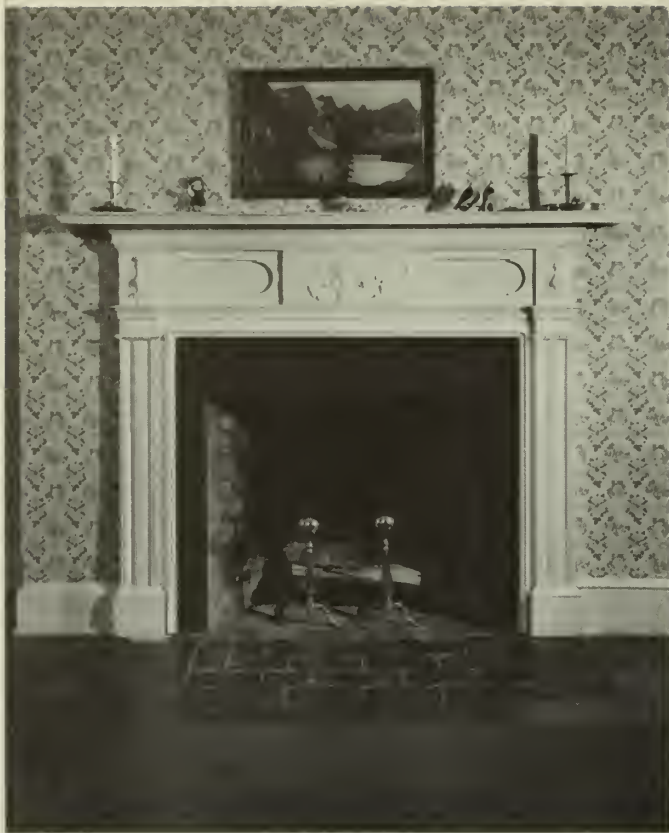
Andrew Ross Tenant House I
fireplace, third floor

1. Architectural character: 1208 30th Street is a good example of a Federal house which is modest in elaboration but ample in size. Its simple, well-proportioned facade and its plain interiors--ornamented only by mantelpieces and fine furnishings--are typical of the merchant class homes of the period.
2. Condition of fabric: Both the interior and the exterior are in good to excellent condition. There has been alteration of the exterior as the facade has been marred by a recent sand-blasting and the rear elevation (west) has been repainted. The interiors have been altered significantly by the addition of a series of 20th century stud partitions.

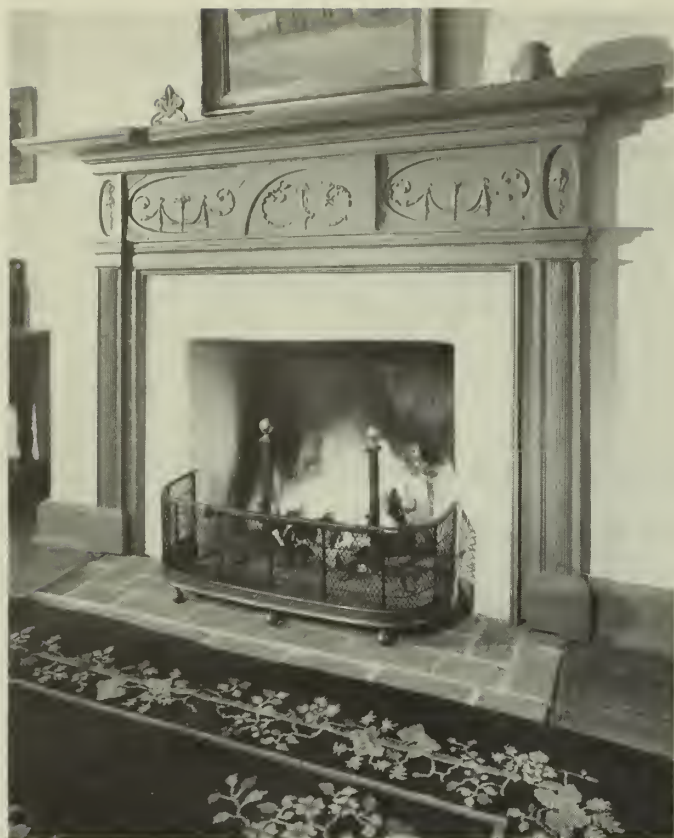
Andrew Ross Tenant House II
fireplace, third floor

1. Architectural character: 1210 30th Street is a good example of a Federal house which is modest in elaboration but ample in size. Its simple well proportioned facade and its plain interiors — ornamented only by mantelpieces and fine furnishings — are typical of the merchant class homes of the period.
2. Condition of fabric: Both the interior and the exteriors are in good-excellent condition. The entire house has been restored by Carroll Curtice, architect, in 1967. Most of the features of the interior however are early 19th century originals and all of these elements of trim and mantelpieces are said by the owner to have been present in the house at the time of restoration.

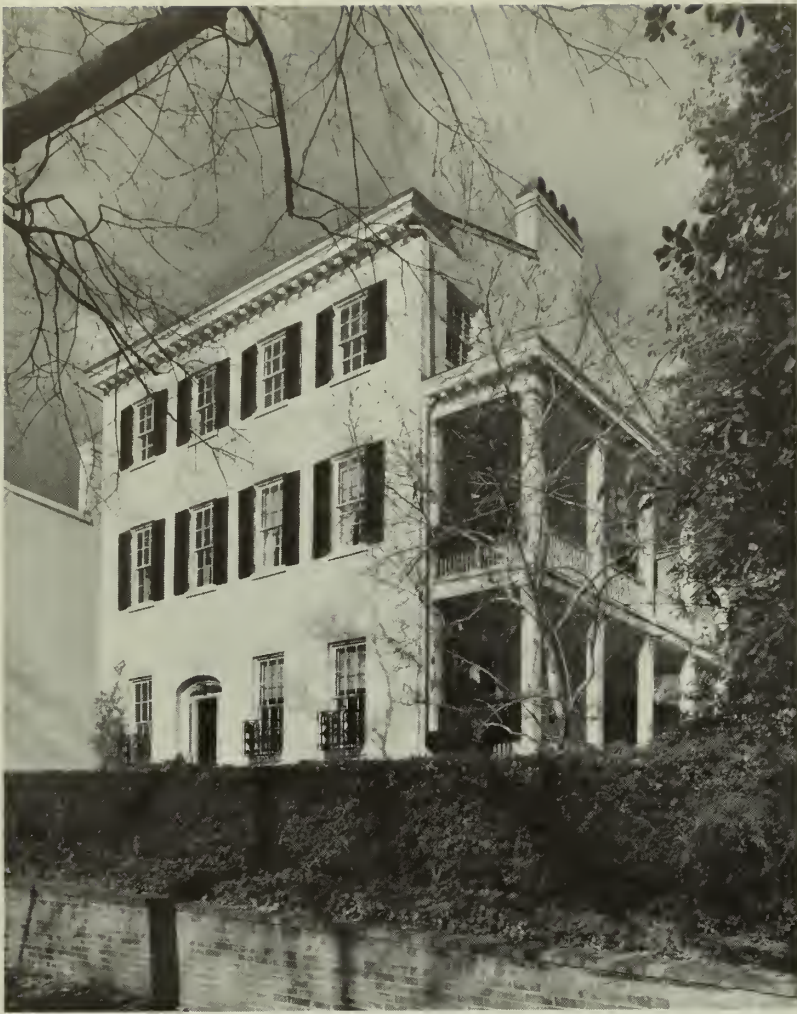
Crawford-Cassin House

2. Condition of fabric: The building is in good condition throughout, considering the many alterations and additions over the years.

2. Foundations: The brick foundation is exposed approximately 4' across the front (south) elevation, sloping along the sides to approximately 2' across the rear (north) elevation.

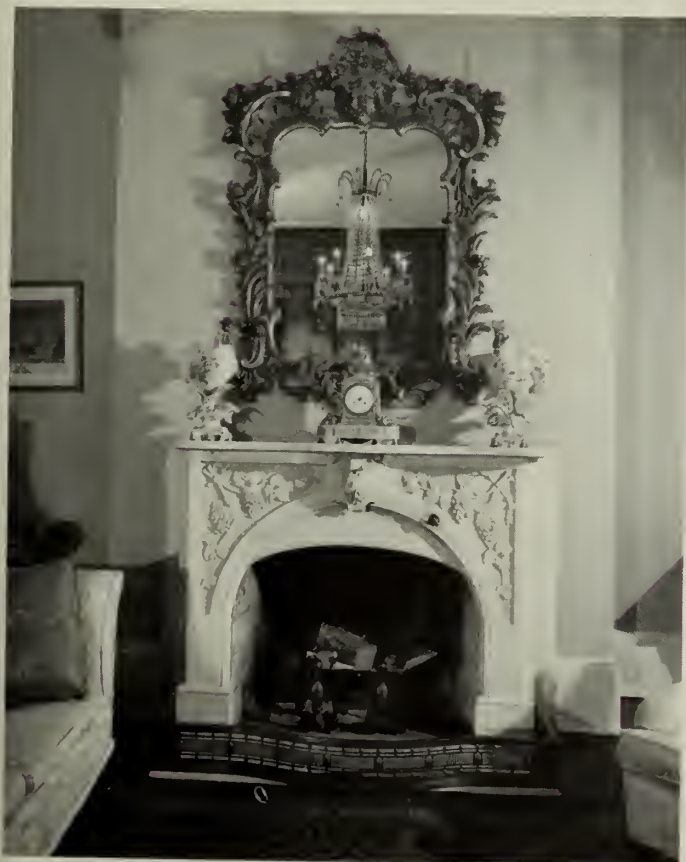
fireplace, living room

The drawing room mantelpiece, while not original, is particularly fine. It is of white marble with an arched opening having grape carvings in the spandrels and a bunch of grapes in the keyblock. It has been converted to a wood burning fireplace by reducing the height of the opening. The southwest study has a wood mantelpiece with a simple Tudor arch supported on flat pilasters. A similar mantelpiece occurs in the southeast bedroom on the second floor and the southeast bedroom on the third floor. The southwest second floor bedroom mantel has full-round Tuscan columns at each side supporting square impost blocks with a broad Greek ovolo bedmould under the shelf. The 10" entablature is horizontally reeded.

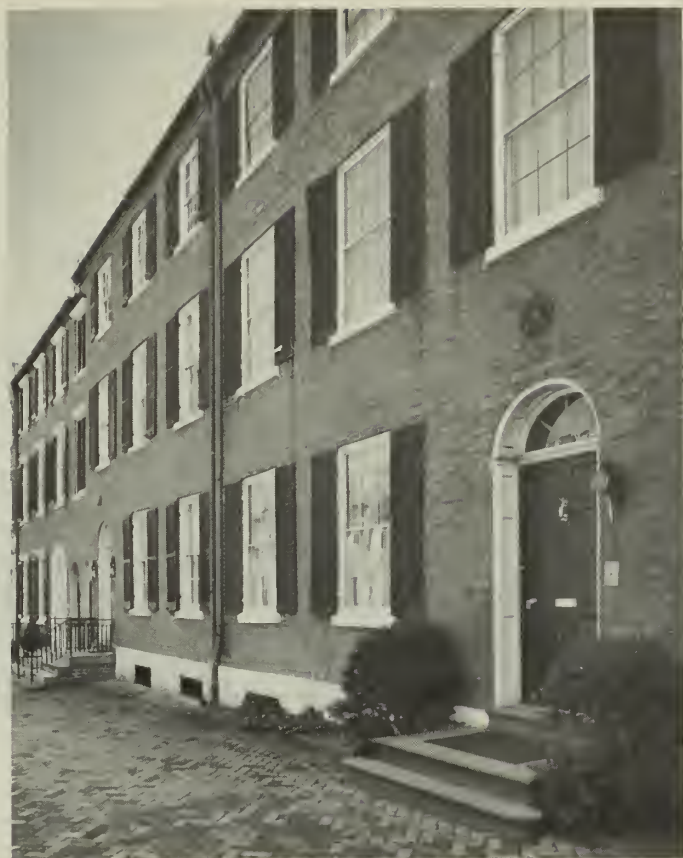
2. Condition of fabric: Both the interior and the exterior are in good-excellent condition. The home is quite well preserved and generally free from extensive later intrusions, renovations or subtractions.

2. Foundations: The brick bearing wall is carried down as a foundation and is exposed 1' 6" below the first floor at the north elevation and 2' 6" at the south elevation.
3. Wall construction: At the south and west elevations the brickwork is of common bond with header rows every 6 courses, while at the front (north) elevation the brick is in Flemish bond with fine beaded joints.
4. Framing: Roof framing is visible and consists of 3" x 6" wood rafters which are probably 19th century and 2" x 10" tie boards which are probably later additions. Other framing of the house is not visible.
5. Porches, stoops, bulkheads, etc.: At the east side of the south elevation a wood framed enclosed link gives access at 1 1/2' below the first floor level to the kitchen out building to the south.

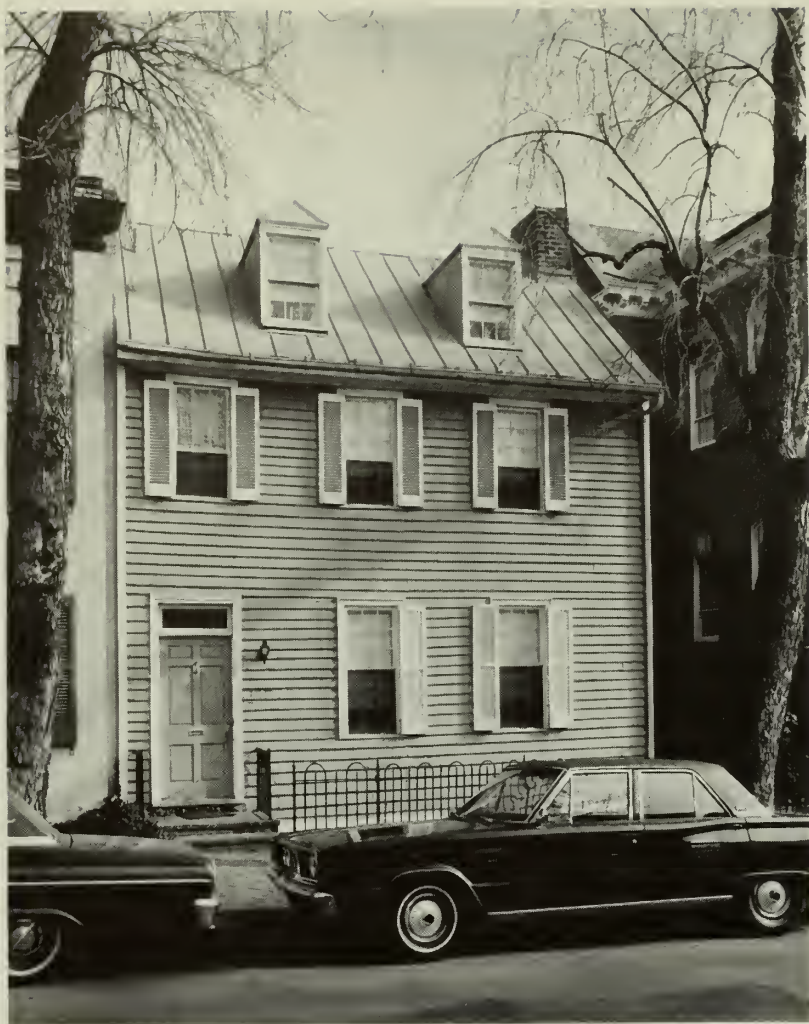
Methodist-Episcopal
Parsonage House

2. Condition of fabric: Both interior and exterior are in good-excellent condition. The interior has been extensively remodelled but the basic floor plan and the five wood mantelpieces remain in place and intact.

2. Foundations: Foundations are of brick with an exposure above street level of 1' at the west elevation and approximately 9' at the east elevation of the main block of the house.

- b. Windows and shutters: Wood sash windows of the house vary considerably from floor to floor and from front to rear. The west facade has 9/6 light double-hung sash on the second floor and 9/9 light sash on the first floor. Most of these have had their early 19th century sash replaced. Other windows of the west section include 2/2 light double-hung sash at the east elevation of the second floor and a 9/9 light double-hung sash at each side of the fireplace at the first floor. All of these appear to be later 19th century or 20th century replacements. In the rear portion of the house the pairs of windows at the north and south sides of the dining room are 6/6 light double-hung sash. The upper sash of the two north windows appear to be 19th century.

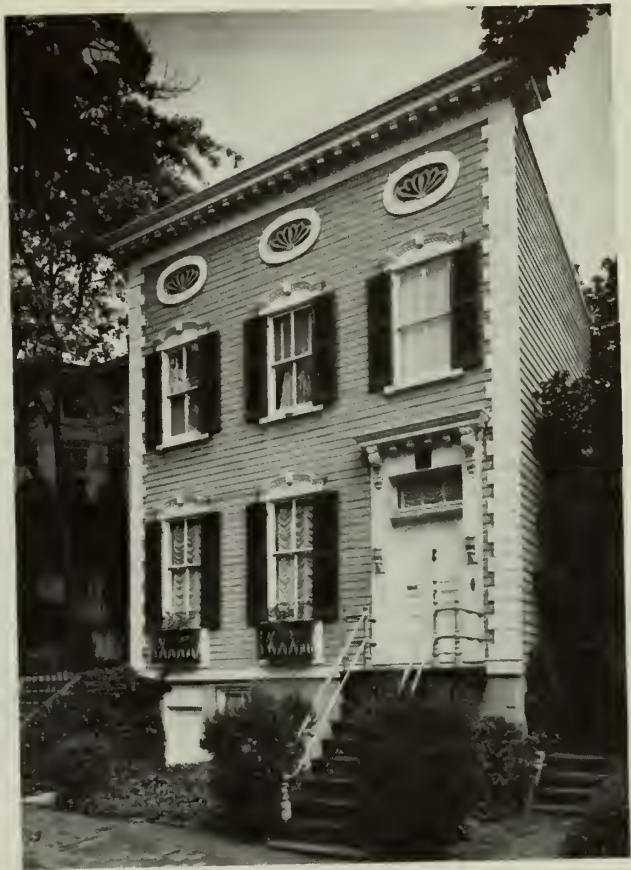
Federal/Victorian Frame House
south facade

2. Foundations: The Southern mid-19th century block of the house has a brick foundation wall exposed approximately 6' at the South elevation. The early 19th century portion has an uncoursed granite block foundation, and the foundation for the 20th century kitchen addition to the North is of brick.

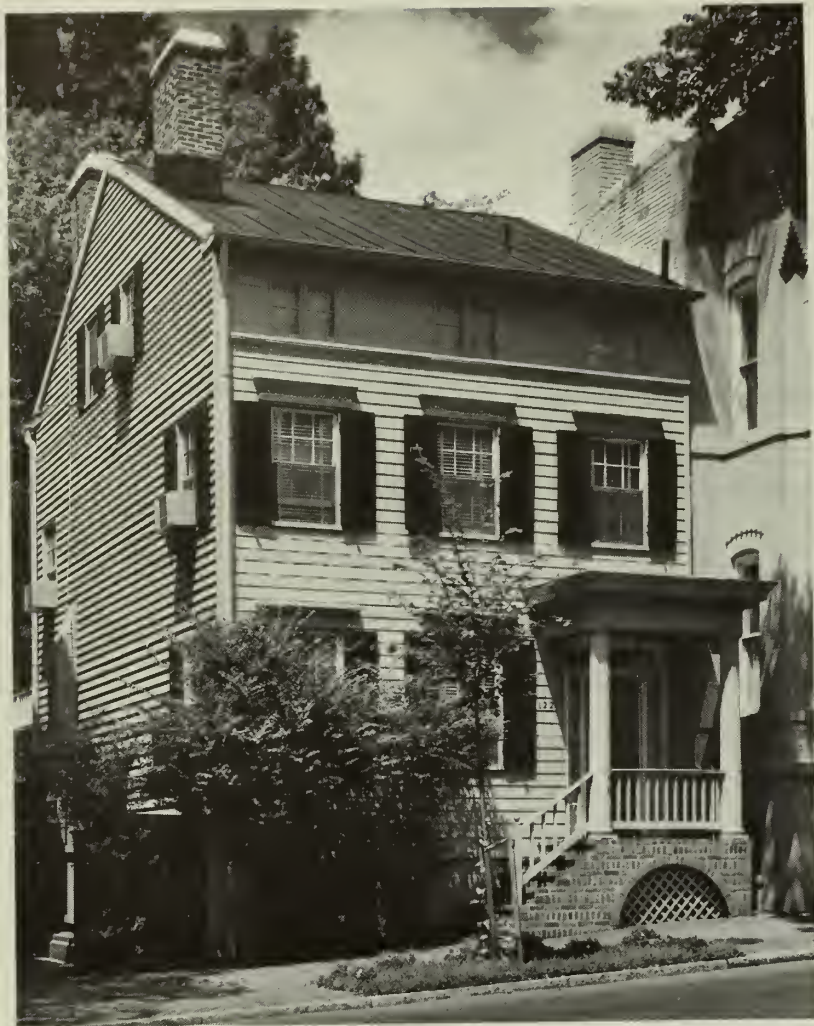
William Knowles House

1. Architectural character: 1228 30th Street is a good example
of a transitional, Federal-Greek Revival building of the
middle of the 19th Century. The house is modest in size
and restrained in detail both internally and externally.
The major "experience" of the dwelling is that of entry,
beginning with the two column portico and ending with a
view up the finely detailed staircase.
2. Condition of fabric: The house has been renovated and
restored. Both the interior and the exterior are in
excellent general condition.

2. Foundations: The brick foundation wall is exposed below the wood siding 3'1" on the East elevation and is approximately 6" above grade at the West elevation of the main section. Perpendicular to the South wall there are two pairs of brick walls which support the chimneys above. These walls are spanned at the first floor level with wood lintels to support the hearth.

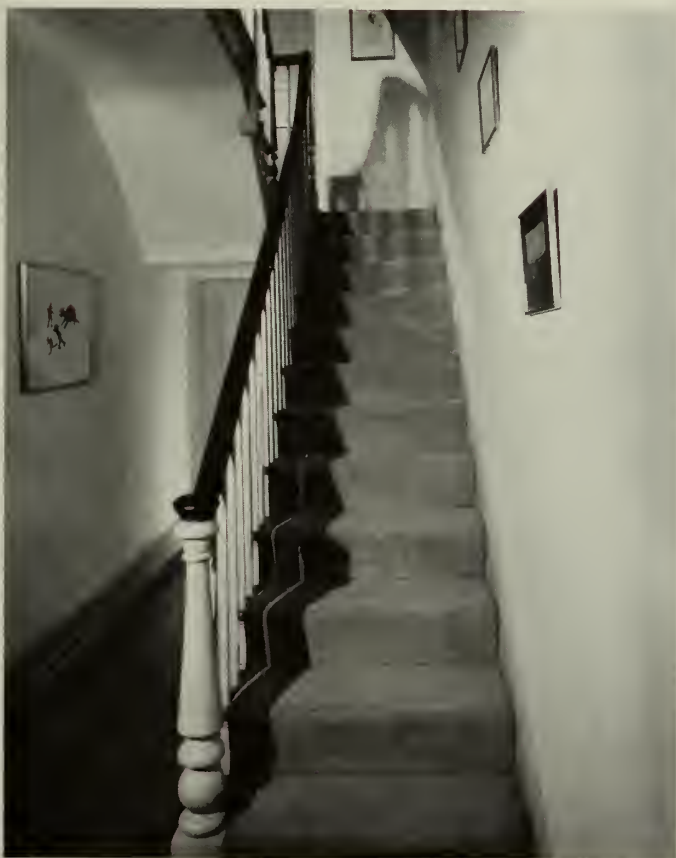
main staircase,

A second stairway occupies the Northwest corner of the rear section beginning at the West wall of the main gabled block. It is a half-turn stair with corner winders at both the beginning and the end of the run. The stair opening to the second floor is now blocked but the 2'-0" wide stair is twelve 8" risers from the East to the West along the North wall. The newel posts and the balusters of this stair appear to be replacement of original wood members. The stringer features here are also of a wave pattern wood appliqué differing from that of the main staircase.

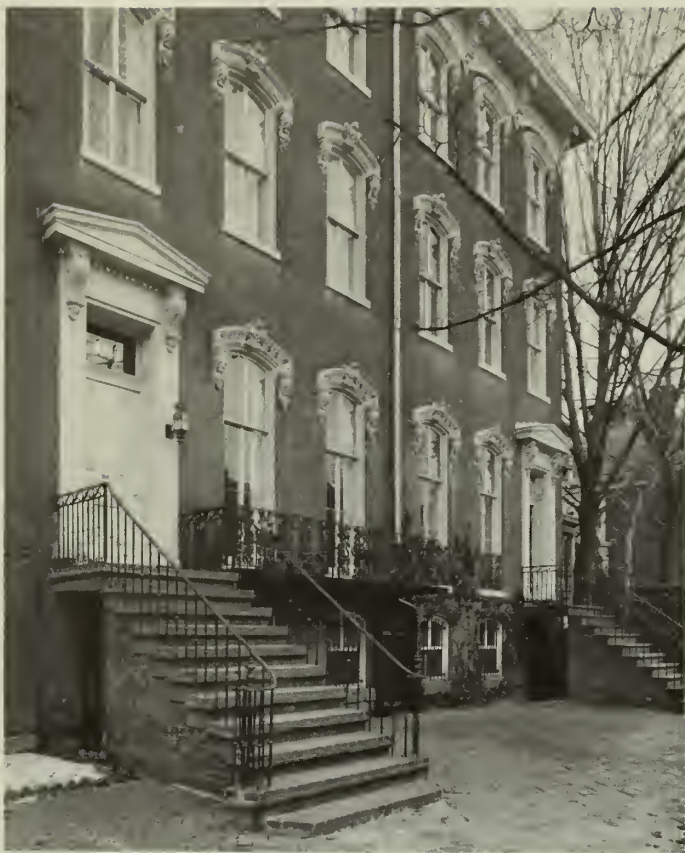
Wheatley Town House

1. Architectural character: With its twin to the East, 3043 N Street is one of the finest examples in Georgetown of an upper class Middle Victorian row house. A general openness characterizes the interior arrangement as the high ceiled rooms are connected by large scale openings and the first floor gives views to both the street and to the rear yard through wide floor-ceiling windows. The facade presents the customary solidity and richness to the street.
2. Condition of fabric: Having been repaired and cleaned within the last five years, the house is in excellent condition on both the interior and exterior.

1. Overall dimensions: This three story brick row house faces South onto N Street between 30th and 31st Streets; its West wall is approximately 105' along N Street from the centerline of 31st Street. The three bay front is 22'-8" wide and the depth of the house is approximately 35'.
2. Foundations: The brick foundation walls of the basement are revealed approximately 6'-8" on the front (South) elevation and approximately 7'-6" on the rear (North) elevation. At the South elevation a red-gray sandstone water table occurs at the sill level of the basement windows.
3. Wall construction: This wall bearing brick structure has a rear (North) elevation faced with rough textured red brick laid in common bond with header courses every six rows. The first two stories are painted white while the third remains its unpainted red-orange color.
